**FLIGHT TEST NOTES**  
Rocket Autopilot Project  
Dave

**24 July 2011, Brothers OR (OROC) – Flight #42, “Rev 4.2.1” hardware flight #8**

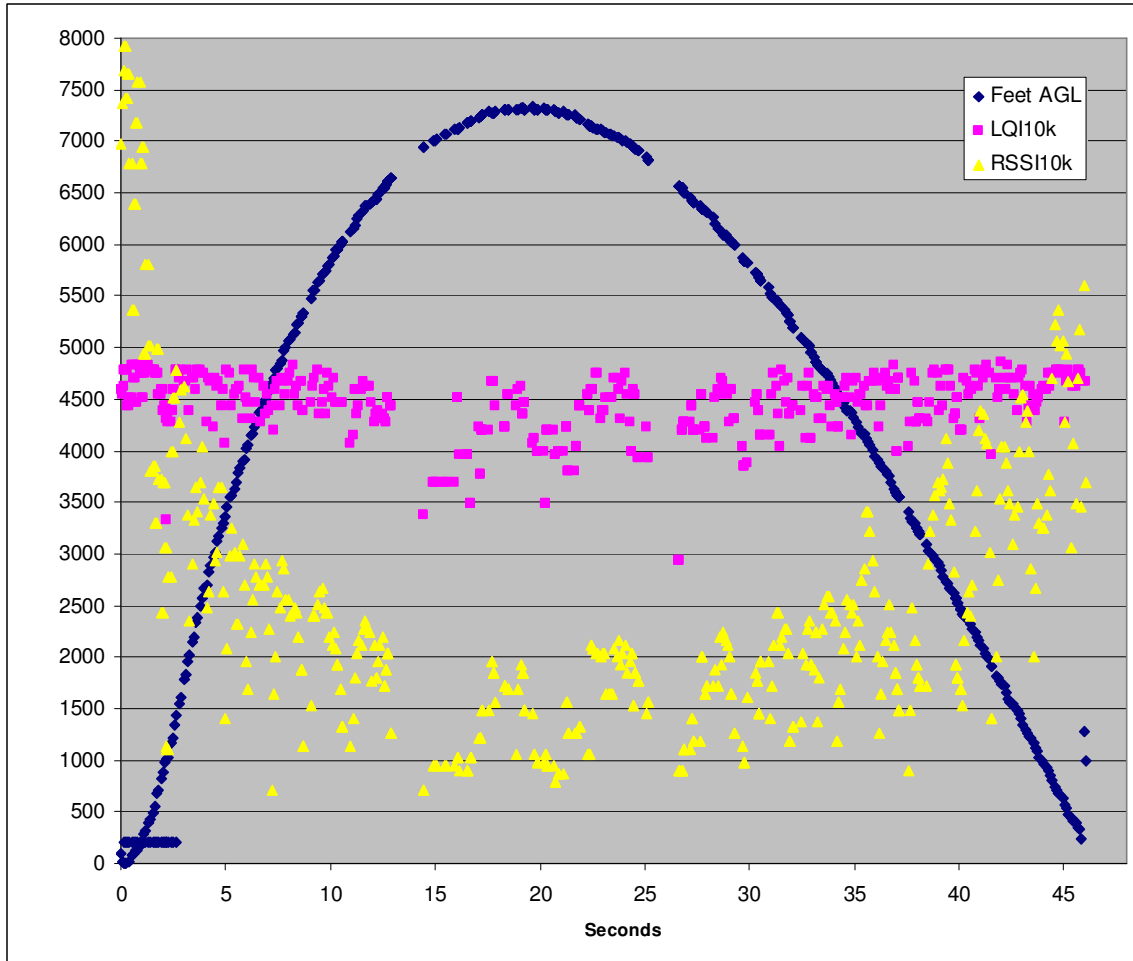
The flight was a useful radio range check; the graph below plots time against AGL altitude, RSSI, and LQI, both scaled to 10,000 as the max reading (all from telemetry). Radio link is a pair of Microchip MRF24J40MB boards. Line of sight range appears to be about 1.5 miles; maybe a bit longer.

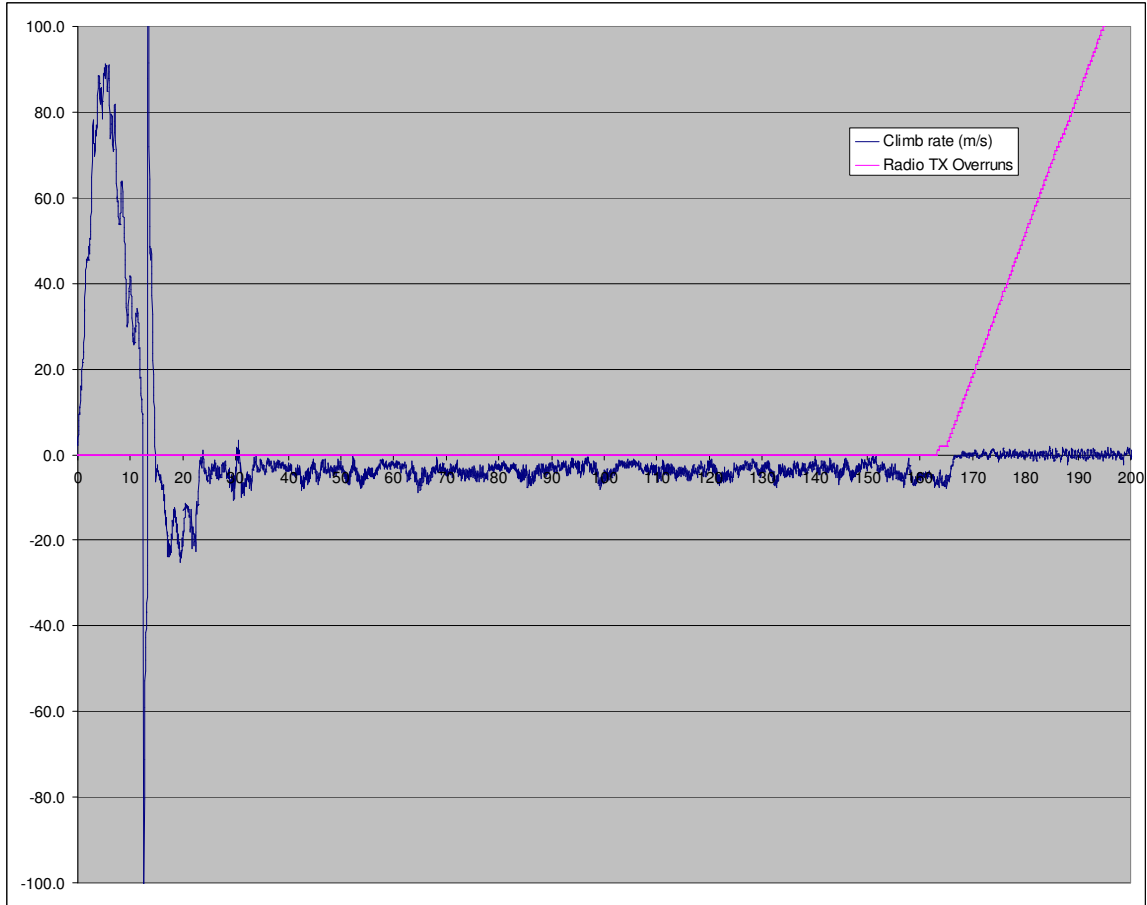
The plot of time vs. climb rate and TX overruns is interesting. TX overruns begin as soon as signal is lost (over horizon).

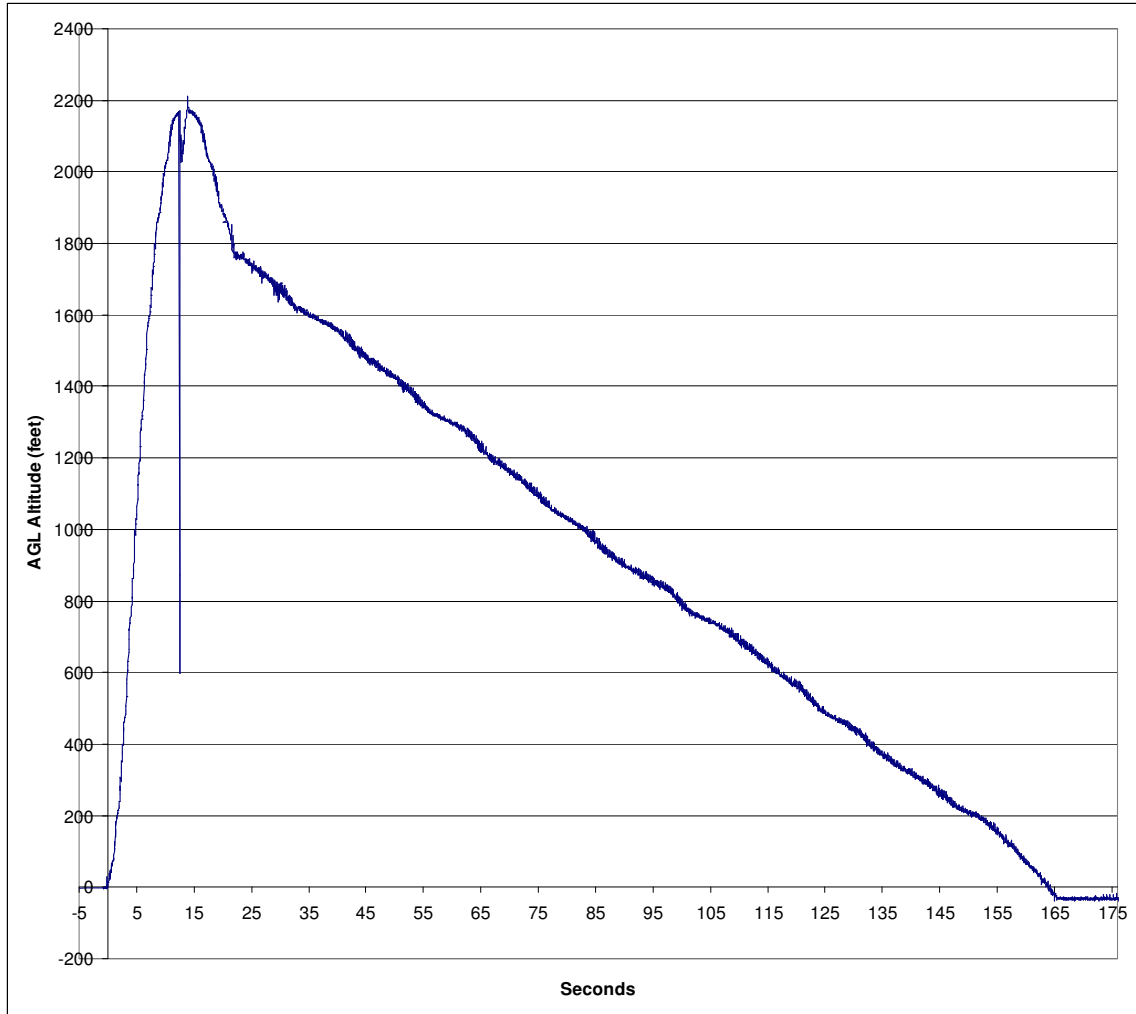
The higher descent rate before full parachute inflation is seen clearly in the altimeter data (below). Note the big spike at parachute deployment – this is caused by the overpressure from the ejection charge (it’s a pressure altimeter).
